**DEPARTMENT OF TRANSPORTATION**

Contract #: 04-0120F4Cty: SF/ALA Rte: 80 PM: 13.2/13.9File #: 69.28**WELDING INSPECTION REPORT****Resident Engineer:** Pursell, Gary**Address:** 333 Burma Road**City:** Oakland, CA 94607**Report No:** WIR-010632**Date Inspected:** 24-Nov-2009**Project Name:** SAS Superstructure**OSM Arrival Time:** 645**Prime Contractor:** American Bridge/Fluor Enterprises, a JV**OSM Departure Time:** 1845**Contractor:** Zhenhua Port Machinery Company, Ltd (ZPMC), Changxing Island **Location:** Shanghai, China

<b>CWI Name:</b>	An Qin Xiang, Yu Dong Ping.			<b>CWI Present:</b>	<b>Yes</b>	<b>No</b>	
<b>Inspected CWI report:</b>	<b>Yes</b>	<b>No</b>	<b>N/A</b>	<b>Rod Oven in Use:</b>	<b>Yes</b>	<b>No</b>	<b>N/A</b>
<b>Electrode to specification:</b>	<b>Yes</b>	<b>No</b>	<b>N/A</b>	<b>Weld Procedures Followed:</b>	<b>Yes</b>	<b>No</b>	<b>N/A</b>
<b>Qualified Welders:</b>	<b>Yes</b>	<b>No</b>	<b>N/A</b>	<b>Verified Joint Fit-up:</b>	<b>Yes</b>	<b>No</b>	<b>N/A</b>
<b>Approved Drawings:</b>	<b>Yes</b>	<b>No</b>	<b>N/A</b>	<b>Approved WPS:</b>	<b>Yes</b>	<b>No</b>	<b>N/A</b>
				<b>Delayed / Cancelled:</b>	<b>Yes</b>	<b>No</b>	<b>N/A</b>
<b>Bridge No:</b>	34-0006			<b>Co

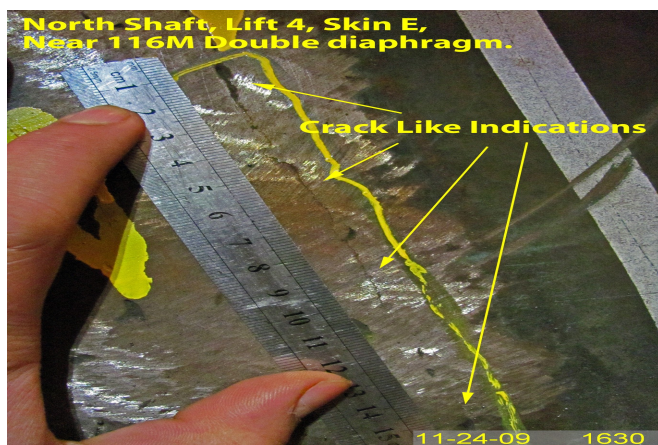
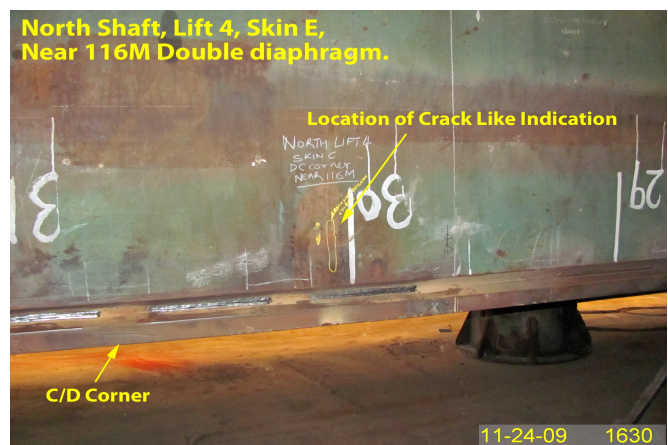
Bay 10, North Tower, Lift 4, Temporary Attachment Area.

During random visual inspection at North Tower, Lift 4(Temporary Attachment Area near 116M Double Diaphragm at Corner Seam C/D) this Caltrans Quality Assurance (QA) Inspector observed “Crack Like” indications at the removed Temporary attachment Weld area. The indications were shown to ZPMC and ABF QC Inspectors. No Incident Report has been written on this issue. The attached photographs provide additional detail.
